Evaluation of fiber optic installation methods, a case study on micro-trenching in Alberta, Canada

Hediyeh Vaseli^a, Leila Hashemian^a, Alireza Bayat^{a*}, Leon Gay^b, Ian Williams^c, and Jordan Melzer^d

Micro-trenching is an innovative and discreet utility installation method that includes the creation of a narrow trench to lay cable or conduit in the ground. To investigate the functionality and durability of micro-trenching in cold regions, two micro-trenching technologies were employed and monitored over the course of two winters in a parking lot in Edmonton, Alberta, Canada. During construction, productivity rate and generated waste material were studied. The installation's physical integrity and optical performance were also evaluated during the monitoring period. Physical integrity was assessed by monitoring the conduit location using ground-penetrating radar (GPR), and an optical time-domain reflectometer (OTDR) test was conducted to determine attenuation in performance. Results indicated that the installation experienced undesirable upward and downward movements in sections with high traffic load, which may be prevented with a more effective reinstatement method. However,

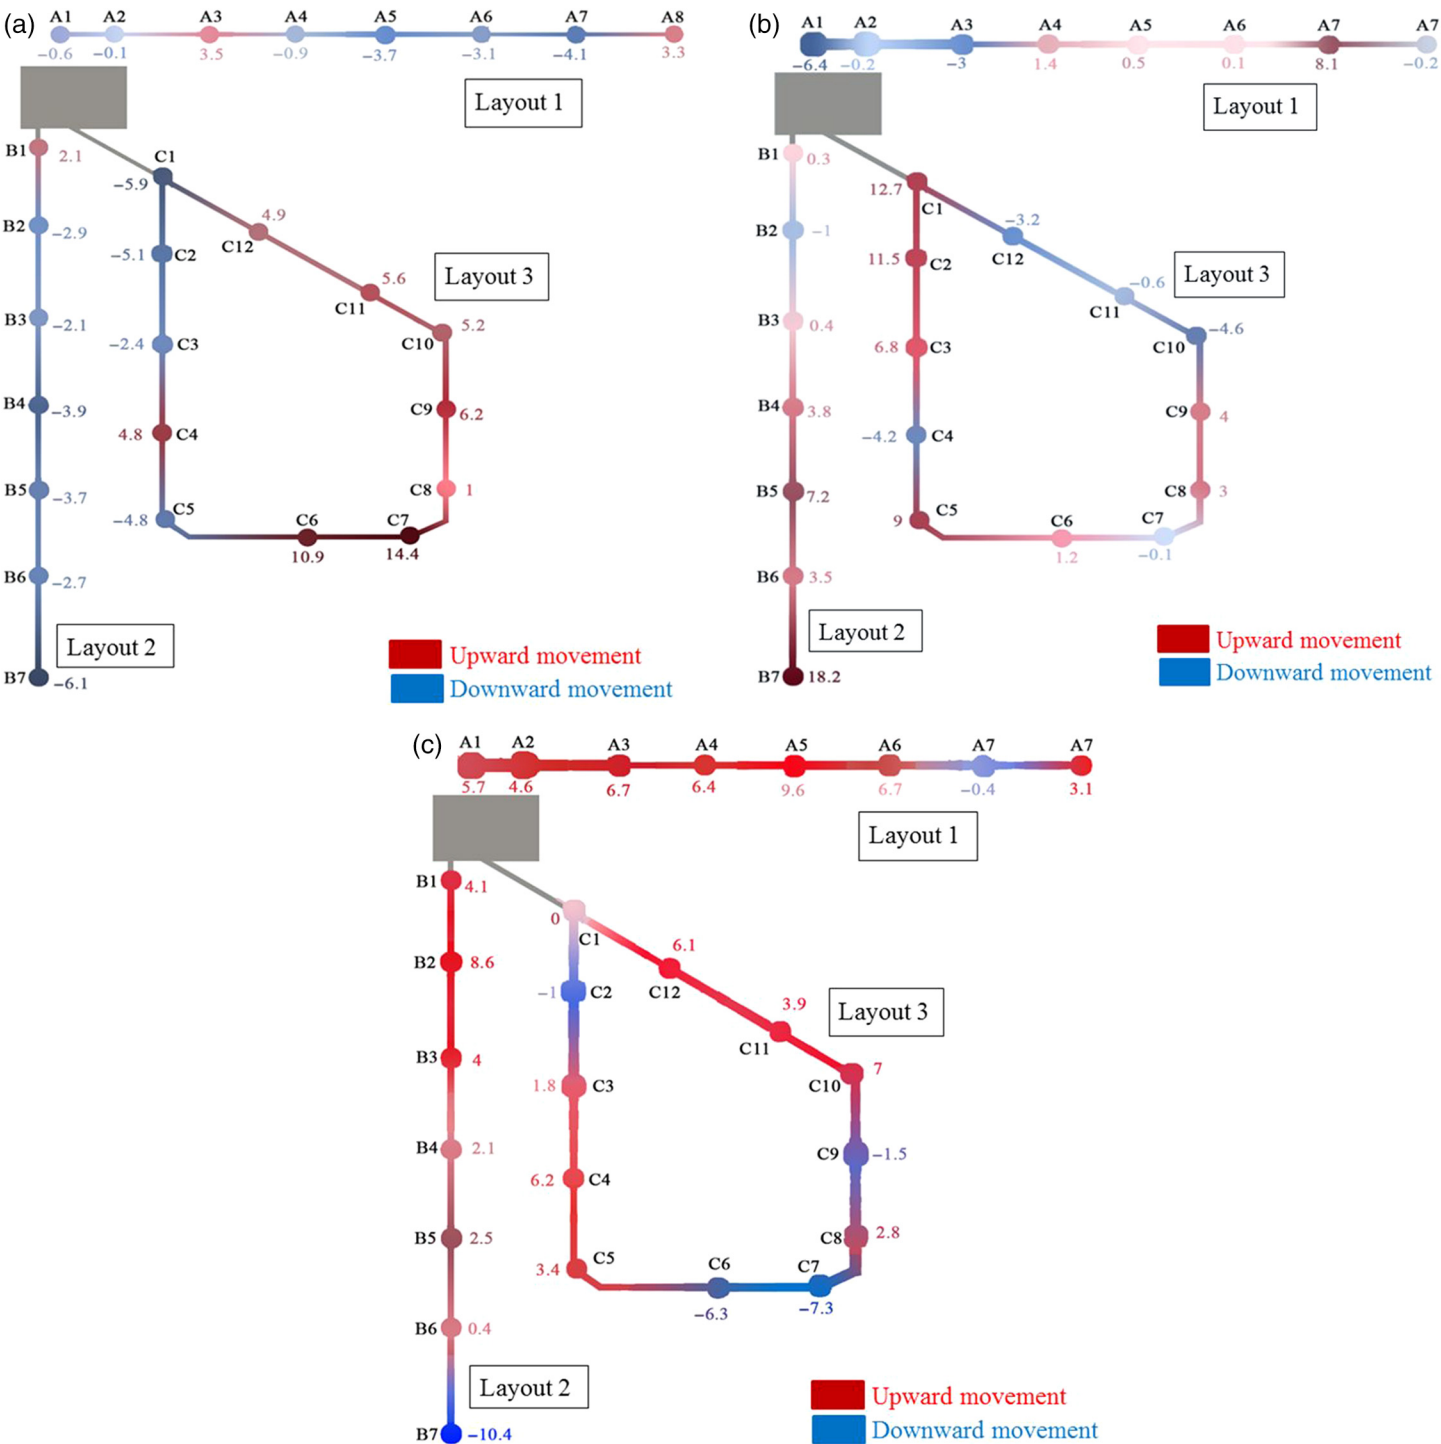
Fig. 8. Conduit location variation relative to surface for vertical inlaid fiber technology: (a) November 2013 to May 2014 (winter), (b) May 2014 to July 2014 (summer), and (c) July 2014 to May 2015 (winter). -, downward movement of the conduit; +, upward movement of the conduit.

Figures 8a–8c and **9** show the seasonal movement of the conduits for both the VIF and SMCI installations from November 2013 to May 2014 (winter), May 2014 to July 2014 (summer), and July 2014 to May 2015 (winter). Negative signs indicate downward movement of the conduits, whereas positive signs indicate upward movement, both of which were measured in centimeters.

In the VIF installations in winter 2014 (**Fig. 8a**), Layouts 1(A) and 2(B) experienced downward movements of up to 6 cm, with the exception of points A3, A8, and B1. The straight section of the loop layout (C) experienced the same movement, with the exception of C4. Conversely, C10–C12 had upward movements of approximately 5 cm. In addition to A3, A8, B1, and C4, these points followed a different trend due to conduit rigidity. When a portion of the conduit rose toward the surface, the other sections sank to maintain conduit stability. In addition, the northeast corner of the loop layout (C6, C7, C8, and C9) had lifted significantly toward the surface.

In the summer of 2014 (Fig. 8b), conduit in Layouts 1(A) and 2(B) moved toward the surface, most significantly at B7 with an upward movement of 18 cm; however, A1 and A3 in Layout 1 experienced downward movements of 6 and 3 cm, respectively. The straight section of Layout 3(C) experienced similar conditions, with an upward movement of 6–12 cm toward the surface at all points except C4. The conduit had little movement in C6 and C7 as maximum movement occurred in winter, and the asphalt layer impeded further upward movement. C10 through C12 and C4 moved downward in response to upward movement in other sections of the loop due to conduit rigidity and stability maintenance.

In winter 2015 (Fig. 8c), Layouts 1(A) and 2(B) moved toward the surface up to 9.6 cm, except at point B7, which had a downward movement of 10 cm. In addition, in Layout 3(C), the conduit moved upward up to 7 cm, except at points C6 and C7, which had a downward movement of 6 and 7 cm, respectively. Points C6 and C7 had the shallowest depths according to the July 2014 GPR inspection.

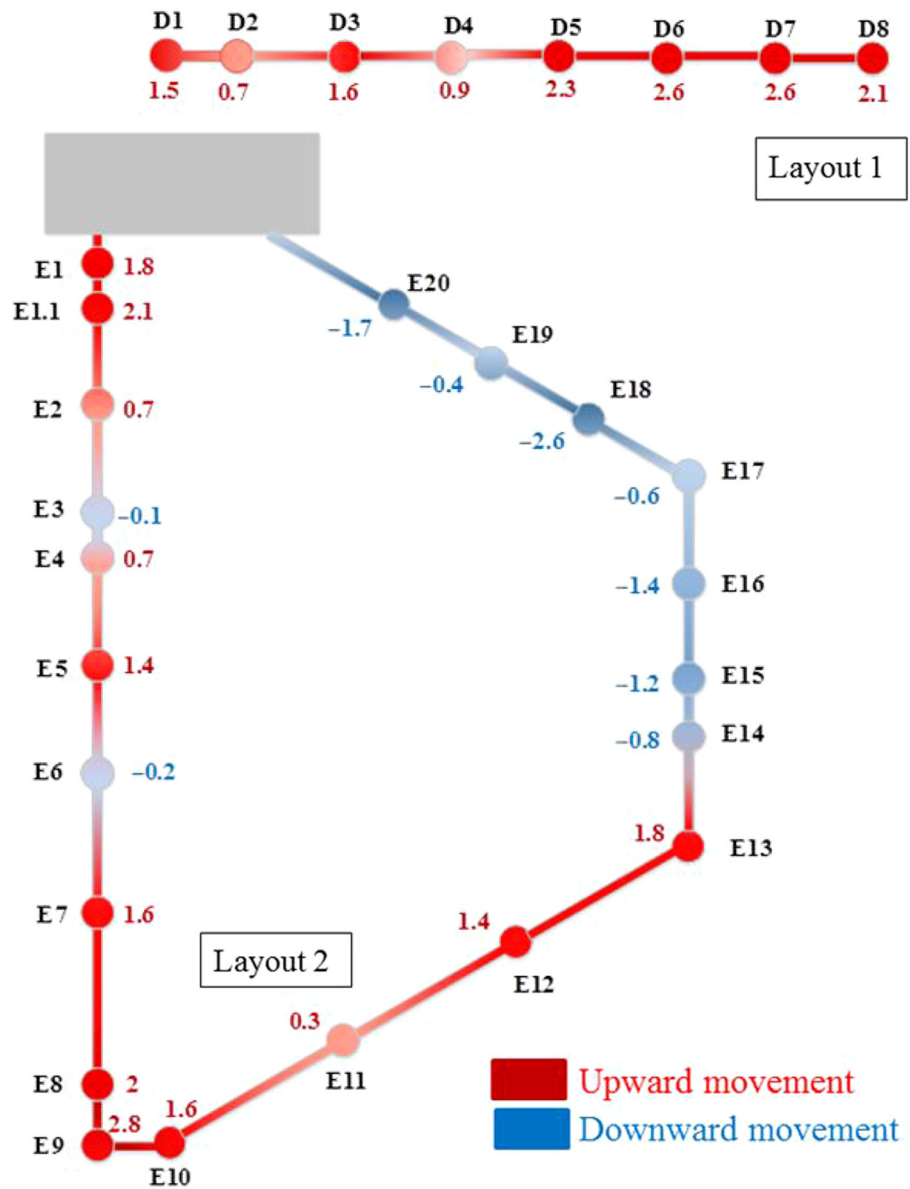
Fig. 9. Conduit location variation relative to surface for surface micro-cable inlay technology: July 2014 to May 2015 (winter). –, downward movement of the conduit; +, upward movement of the conduit.

In the SMCI installation in winter 2015 (Fig. 9), Layout 1(D) and the straight section of Layout 2(E) moved toward the surface up to 2.8 cm. However, the other section of the loop Layout 2(E) had a slight downward movement up to 2.6 cm.
