Evaluation of fiber optic installation methods, a case study on micro-trenching in Alberta, Canada

This paper introduces the micro-trenching method and discusses two different experiments conducted to evaluate installation functionality and FO performance in cold regions two years after installation.

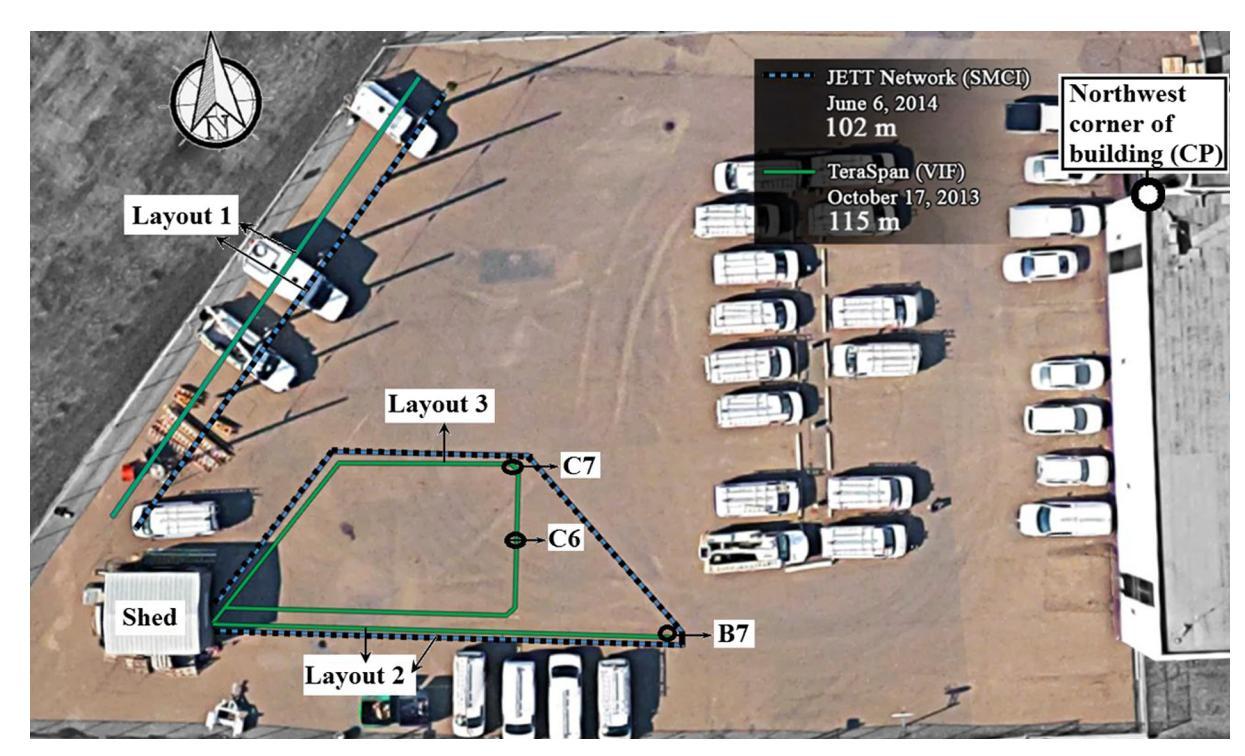
Fig. 1. Installation layouts, control point (CP), and shallowest points (C7, C6, and B7).

Two micro-trenching technologies, vertical inlaid fiber (VIF) and surface micro-cable inlay (SMCI), were used for installation in this experiment. The test installation was located at 2920 66 St NW, Edmonton, Alberta, in a parking lot belonging to a TELUS Communications operational building. TeraSpan conducted the first installation VIF on 17 October 2013. JETT Networks conducted the second installation SMCI on 6 June 2014. Details of the installation layouts (Fig. 1) are as follows:

- VIF technology
 - 1. 30 m straight layout without traffic load
 - 2. 30 m straight layout located in the direct path of traffic
 - 3. 55 m loop layout located in the direct path of traffic
- SMCI technology
 - 1. 30 m straight layout without traffic load
 - 2. 72 m loop layout in the direct path of traffic

the GPR inspection in July 2014. However, it moved downward and now has a depth of 19 cm according to a recent GPR inspection. In addition, in the northeast corner of Layout 3 (loop layout), the conduit depth was significantly shallower than its initial depth in July 2014. In Fig. 6c, it can be seen that C7 and C6, with respective depths of 7 and 9.7 cm according to the GPR inspection in July 2014, were the shallowest points of the conduit profile in Layout 3 and had respective approximate displacements of 14 and 12 cm toward the surface. However, C6 and C7 moved downward and their current depths are 16 and 14 cm, respectively, according to recent GPR inspections. These three points (C6, C7, and B7) were in a more direct path of traffic compared with other points, as depicted in Fig. 1.

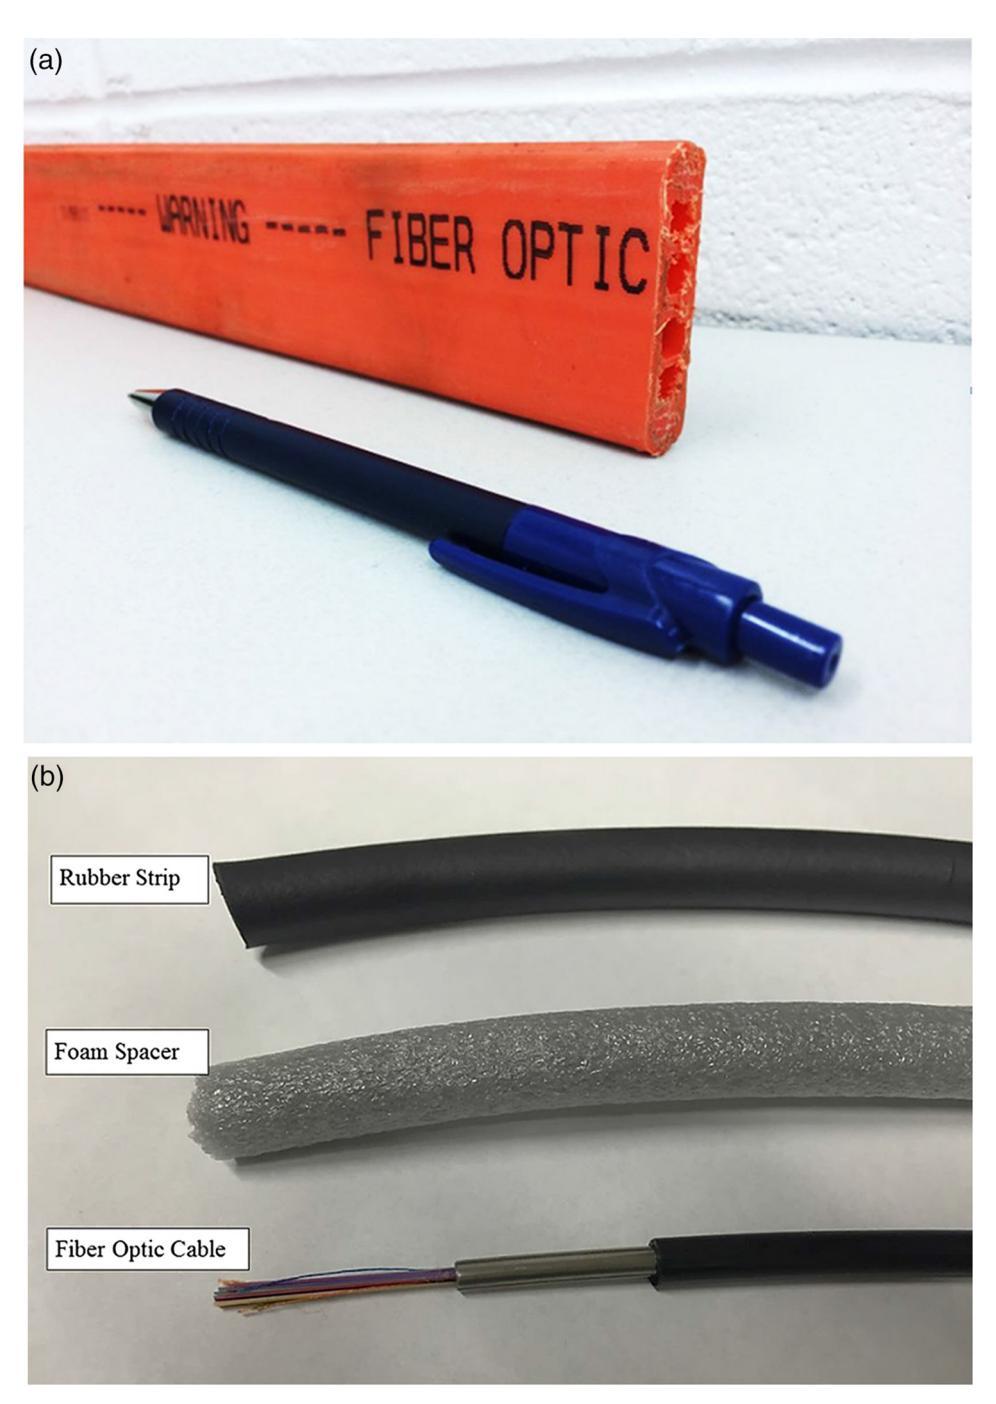
Fig. 2. (a) Vertical deflecting conduit, and (b) surface micro-cable inlay cable, foam spacer, and rubber strip.

This technology uses vertical deflecting conduit (VDC) (**Fig. 2a**), which consists of two robust, slim conduit halves fastened together by a zipper tool to form a channel that encloses the FO cable. FO cables can be zipped, pulled, or blown into the conduits (TeraSpan 2013).

The installation procedure for SMCI technology begins similarly to VIF; once measured, the layout is marked using a thread and spray paint. The trench is wet cut using a Husqvarna FS 4800 D. A vacuum and blower are then used to clean and dry the trench. With this technology, cable installation consists of three phases: laying FO cable in the trench, placing a layer of foam spacer over the cable, and placing a rubber strip over the spacer to secure the cable and foam spacer in the trench. The spacer is round and made from flexible closed cell foam to deter movement caused by freeze/ thaw cycles and protect the cable from moisture and water ingress. The rubber strip is a heat- and chemical-resistant neoprene that holds and fixes the cable and foam spacer in place (Fig. 2b).

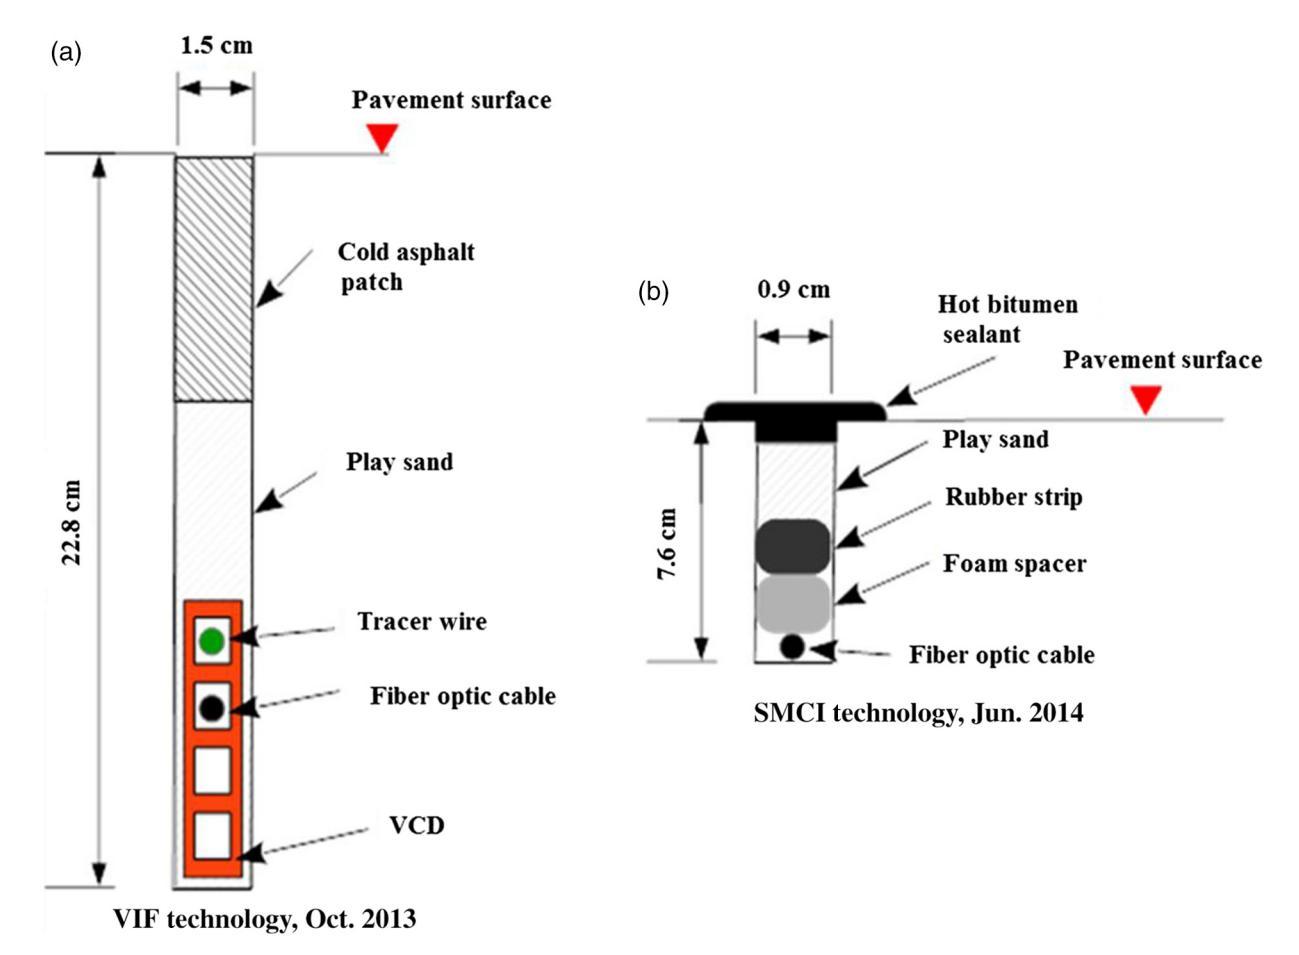
Fig. 3. Cross section of (a) vertical inlaid fiber (VIF) and (b) surface micro-cable inlay (SMCI) installations.

Installation specifications for the VIF technology and a cross section of the SMCI technology are provided in Table 1 and Fig. 3, respectively.

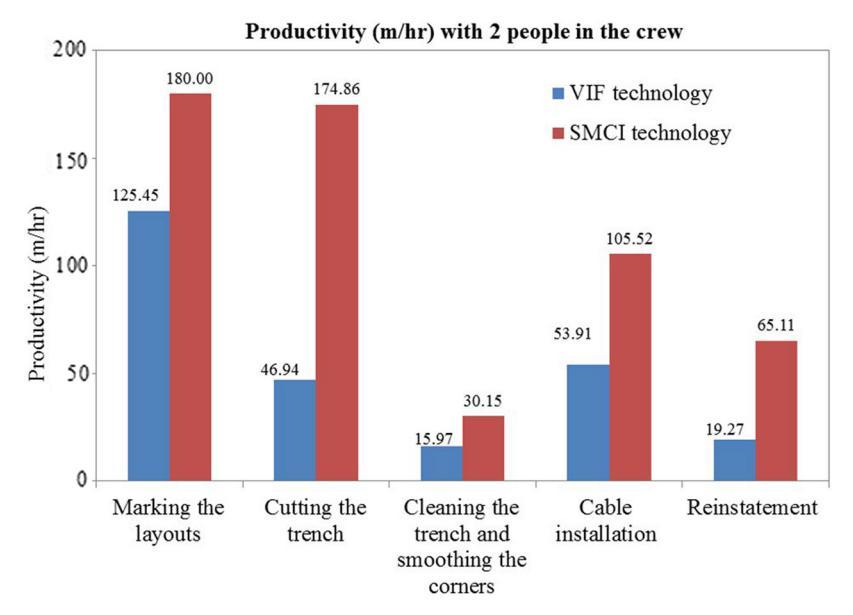
Fig. 4. Productivity rates in both fiber optic (FO) installation technologies.

Figure 4 represents the measured productivity of each micro-trenching activity for both installation technologies using a two-person crew. For both technologies, marking the layout had the highest productivity rate among all activities, whereas cleaning the trench had the lowest productivity rate because it was the most time-consuming activity. Furthermore, the productivity rates of SMCI technology were significantly higher than VIF technology, which was due to the shallower depth of SMCI installations. Shallower depth results in less waste material, less required reinstatement material, and easier creation and reinstatement of the trench. The total micro-trenching productivity associated with VIF and SMCI technologies with a two-person crew was 6.2 and 14.4 m/h, respectively, and considering an 8-h workday, productivity rate was approximately 50 and 115 m/d, respectively. In total, the productivity of SMCI technology was approximately two times that of VIF technology. It should be noted that as the estimated productivity in general; however, the information could be valuable for comparisons with other micro-trenching techniques.

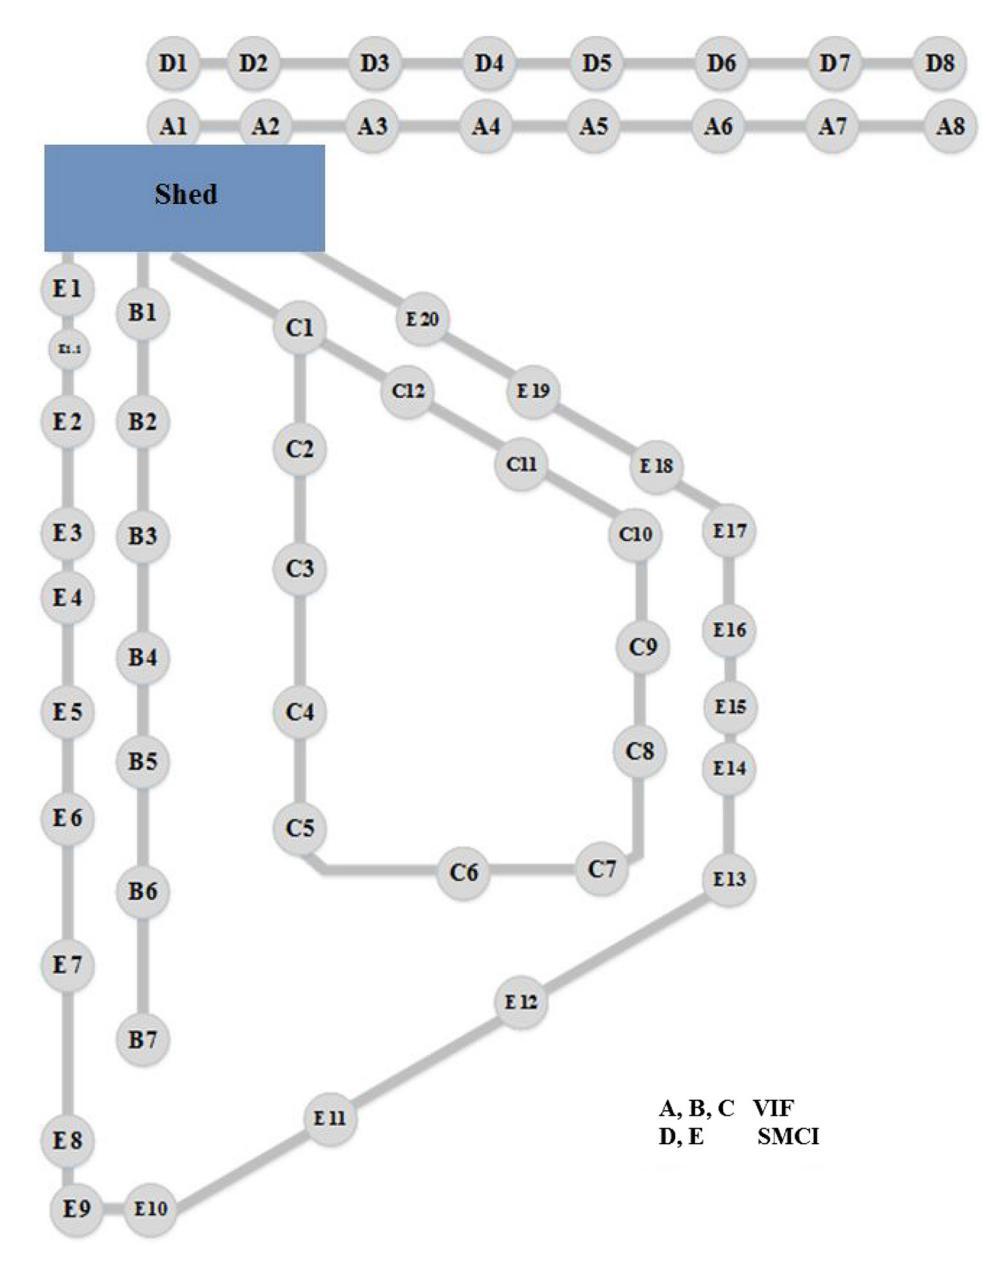
Fig. 5. Ground-penetrating radar-inspected points in vertical inlaid fiber (VIF) and surface micro-cable inlay (SMCI) installations.

In VIF technology, the tracer wire, inserted in the channels of VDC, is a copper-coated wire used to make the conduit more detectable by GPR when determining the location and its movement. To monitor the primary location of the conduit in the micro-trench after each installation, the first GPR inspections were conducted one month after the installations were completed. To investigate the effect of freeze/thaw cycles on the conduit movement, GPR inspections were continued after each winter. **Figure 5** shows the GPR-inspected points in both the VIF and SMCI installations on 8 November 2013, 12 May 2014, 30 July 2014, and 4 May 2015.

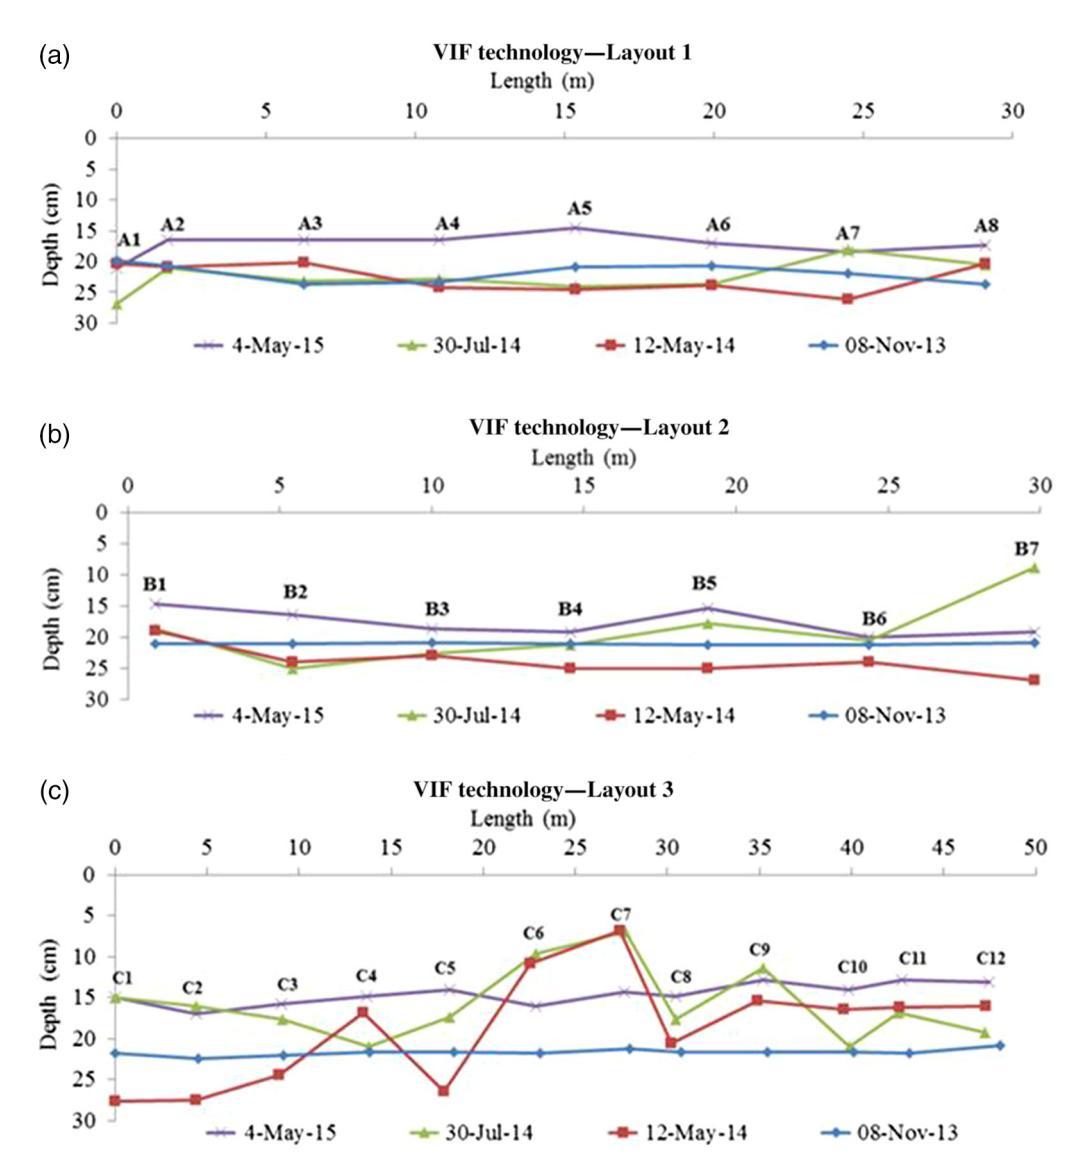
Fig. 6. Conduit profile for vertical inlaid fiber (VIF) technology: (a) Layout 1(A), (b) Layout 2(B), and (c) Layout 3(C).

To investigate the physical integrity of the installation, conduit location was detected using GPR. **Figures 6a–6c** show the conduit profile of Layouts 1(A), 2(B), and 3(C) for VIF technology. It must be noted that the conduit profilewas obtained using its depth relative to the surface. In Layout 3(C), the loop is unfolded, and the conduit profile is provided. Points C5, C7, and C10 were located in the bends of the layout (the intersection of straight lines).

Figures 6a and **b** show that both Layouts 1 and 2 were in relatively good condition with little vertical displacement toward the surface, except at point B7, which had a shallow depth of 8.8 cm according to

Recent GPR inspections demonstrated that although the three layouts showed no significantly shallow points, the installations have moved upward from their installed depth (November 2013). Layout 3(C)

has an average depth of 14.55 cm (compared with 21.5 cm in November 2013); this value is 17.4 cm for Layout 1(A) and Layout 2(B) (compared with 21.5 cm in November 2013).

It can also be concluded that traffic load causes increased conduit movement in layouts with bends compared with strictly straight layouts. In loop layouts, the conduit had increased upward and downward movements, which may have been the result of stresses induced in the bent portions of the layout.

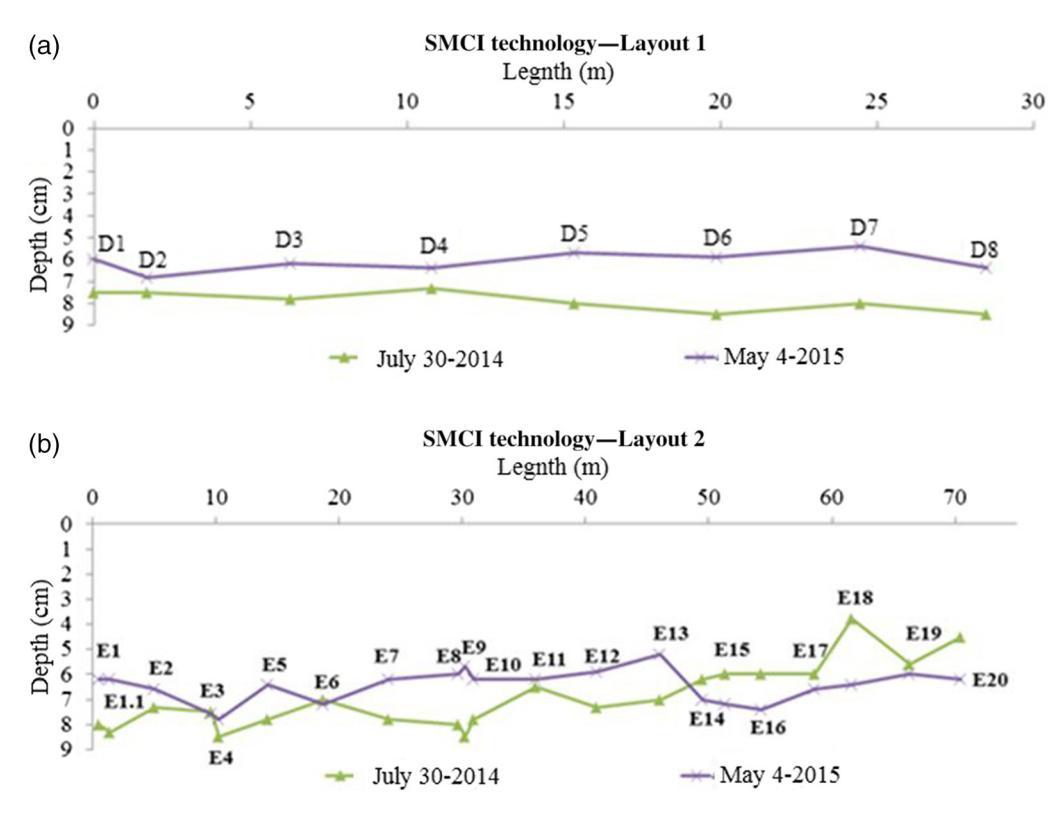
Fig. 7. Conduit profile for SMCI technology: (a) Layout 1(D) and (b) Layout 2(E).

Figures 7a and **b** show the conduit profile of Layouts 1(D) and 2(E) for SMCI technology. It must be noted that the conduit profile was obtained using its depth relative to the surface. In Layout 2(E), the loop is unfolded, and the conduit profile is provided. Points E9, E10, E13, and E17 were located in the bends of the layout (the intersection of straight lines).

The GPR results indicated that there was minimal fluctuation in the upward and downward movements in these installations; however, the installations had an average upward movement toward the surface of 1.7 cm in the straight layout (D) and 0.44 cm in the loop layout (E). The low fluctuation suggests that using a rubber strip and foam spacer to stabilize the cable in the trench is a promising technique, but the installation needs to be inspected for several years to draw stronger conclusions about its effectiveness.

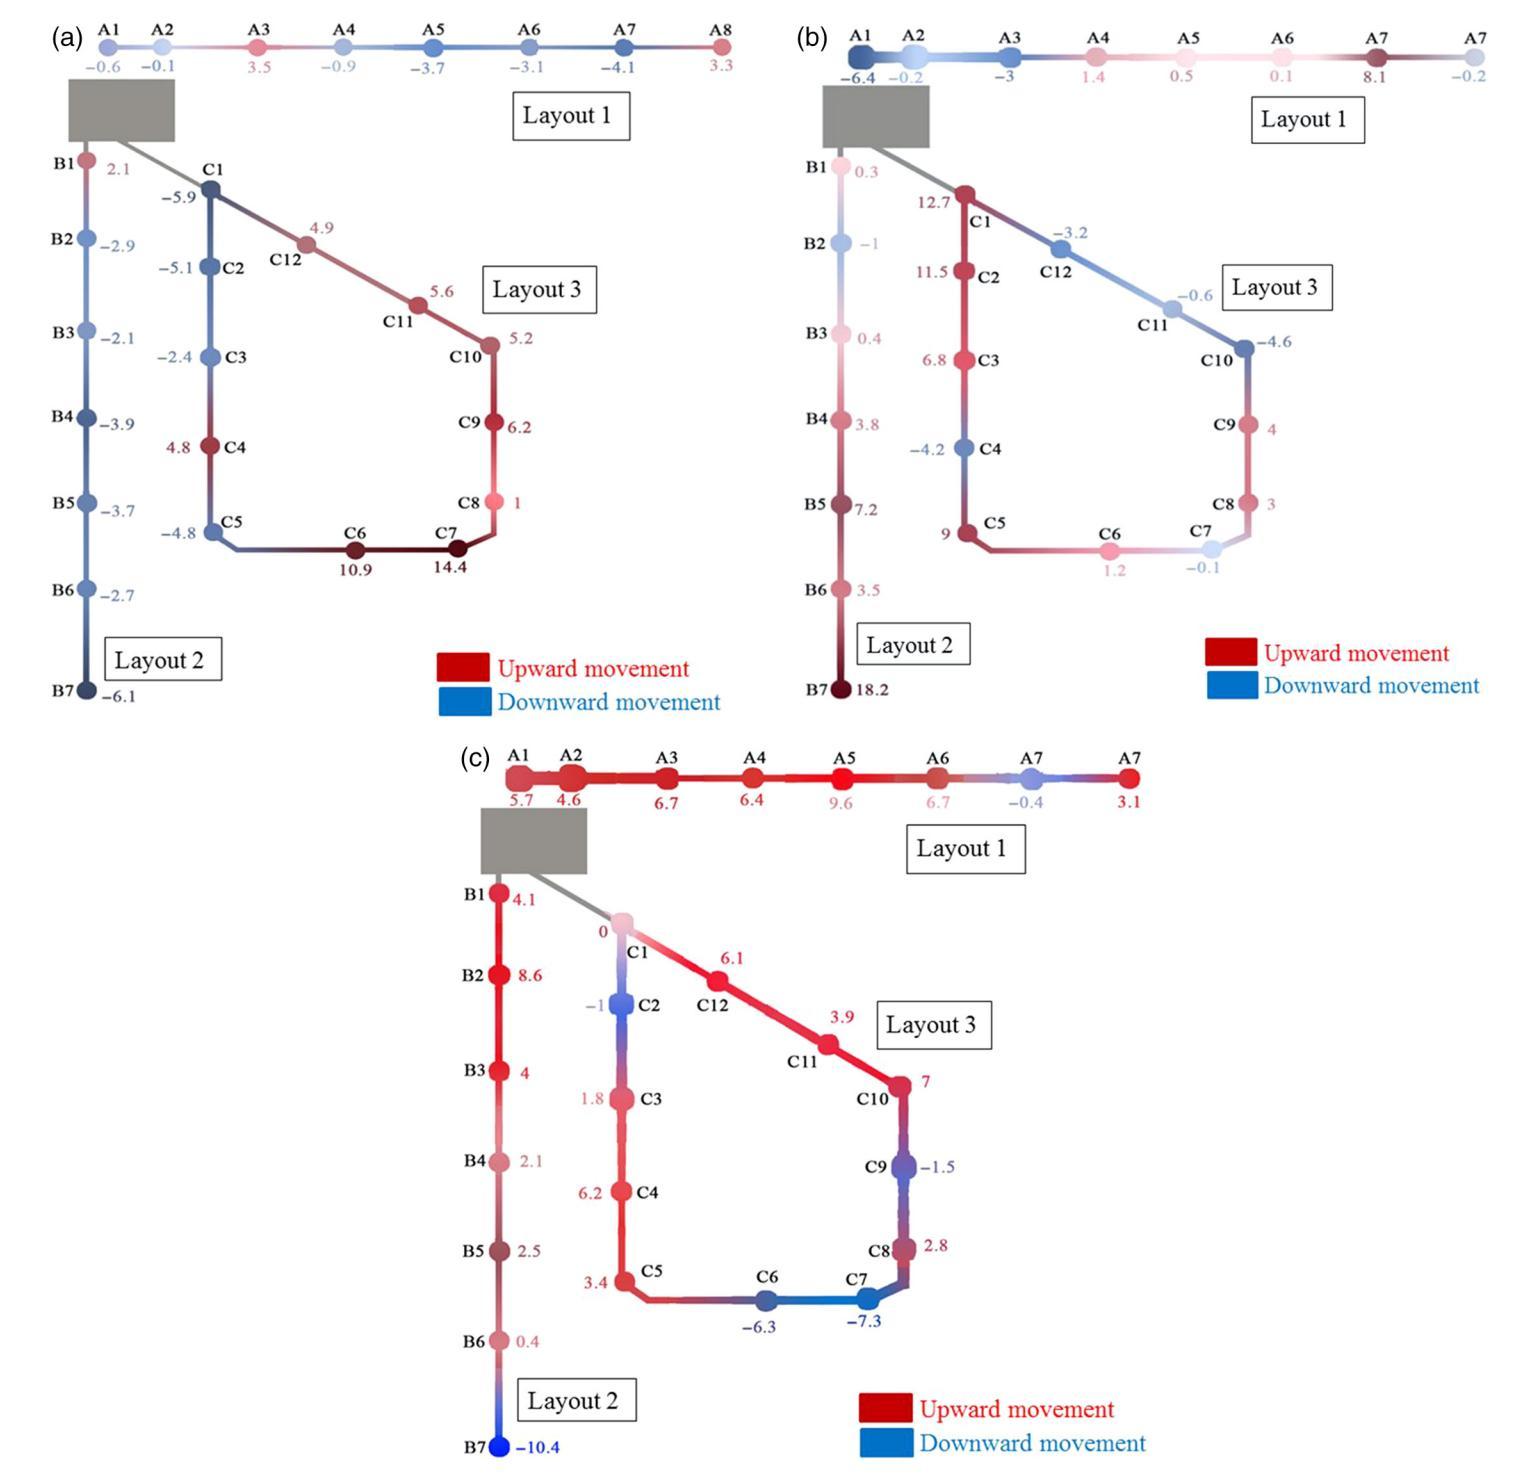
Fig. 8. Conduit location variation relative to surface for vertical inlaid fiber technology: (a) November 2013 to May 2014 (winter), (b) May 2014 to July 2014 (summer), and (c) July 2014 to May 2015 (winter). –, downward movement of the conduit; +, upward movement of the conduit.

Figures 8a–8c and **9** show the seasonal movement of the conduits for both the VIF and SMCI installations from November 2013 to May 2014 (winter), May 2014 to July 2014 (summer), and July 2014 to May 2015 (winter). Negative signs indicate downward movement of the conduits, whereas positive signs indicate upward movement, both of which were measured in centimeters.

In the VIF installations in winter 2014 (Fig. 8a), Layouts 1(A) and 2(B) experienced downward movements of up to 6 cm, with the exception of points A3, A8, and B1. The straight section of the loop layout (C) experienced the same movement, with the exception of C4. Conversely, C10–C12 had upward movements of approximately 5 cm. In addition to A3, A8, B1, and C4, these points followed a different trend due to conduit rigidity. When a portion of the conduit rose toward the surface, the other sections sank to maintain conduit stability. In addition, the northeast corner of the loop layout (C6, C7, C8, and C9) had lifted significantly toward the surface.

In the summer of 2014 (Fig. 8b), conduit in Layouts 1(A) and 2(B) moved toward the surface, most significantly at B7 with an upward movement of 18 cm; however, A1 and A3 in Layout 1 experienced downward movements of 6 and 3 cm, respectively. The straight section of Layout 3(C) experienced similar conditions, with an upward movement of 6–12 cm toward the surface at all points except C4. The conduit had little movement in C6 and C7 as maximum movement occurred in winter, and the asphalt layer impeded further upward movement. C10 through C12 and C4 moved downward in response to upward movement in other sections of the loop due to conduit rigidity and stability maintenance.

In winter 2015 (Fig. 8c), Layouts 1(A) and 2(B) moved toward the surface up to 9.6 cm, except at point B7, which had a downward movement of 10 cm. In addition, in Layout 3(C), the conduit moved upward up to 7 cm, except at points C6 and C7, which had a downward movement of 6 and 7 cm, respectively. Points C6 and C7 had the shallowest depths according to the July 2014 GPR inspection.

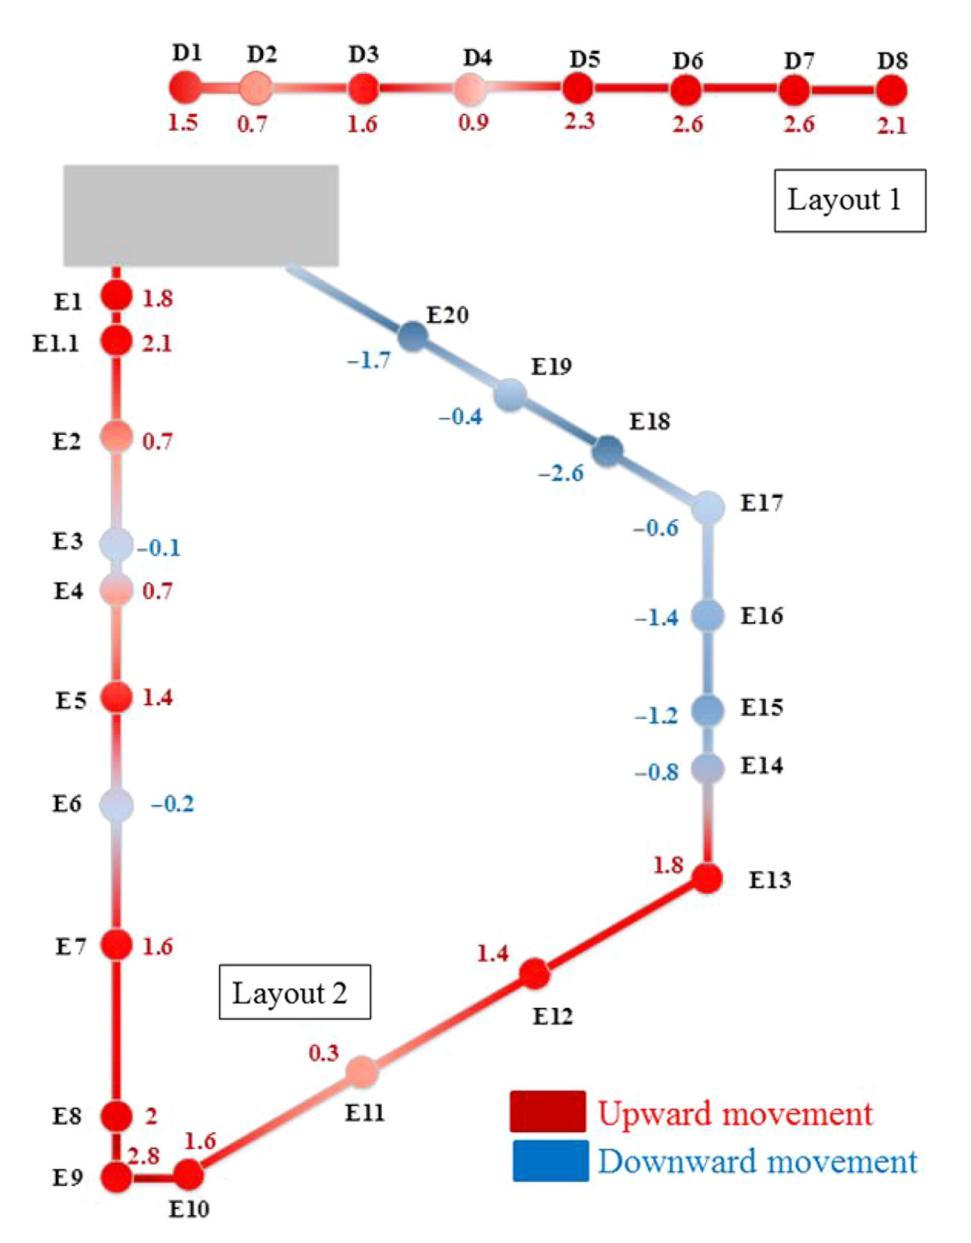
Fig. 9. Conduit location variation relative to surface for surface micro-cable inlay technology: July 2014 to May 2015 (winter). –, downward movement of the conduit; +, upward movement of the conduit.

In the SMCI installation in winter 2015 (Fig. 9), Layout 1(D) and the straight section of Layout 2(E) moved toward the surface up to 2.8 cm. However, the other section of the loop Layout 2(E) had a slight downward movement up to 2.6 cm.
